Design and Construction of Creekside Town Center Bridges

Peter A. Giessel, P.E.
Reid Middleton, Inc.

Creekside Town Center Bridges

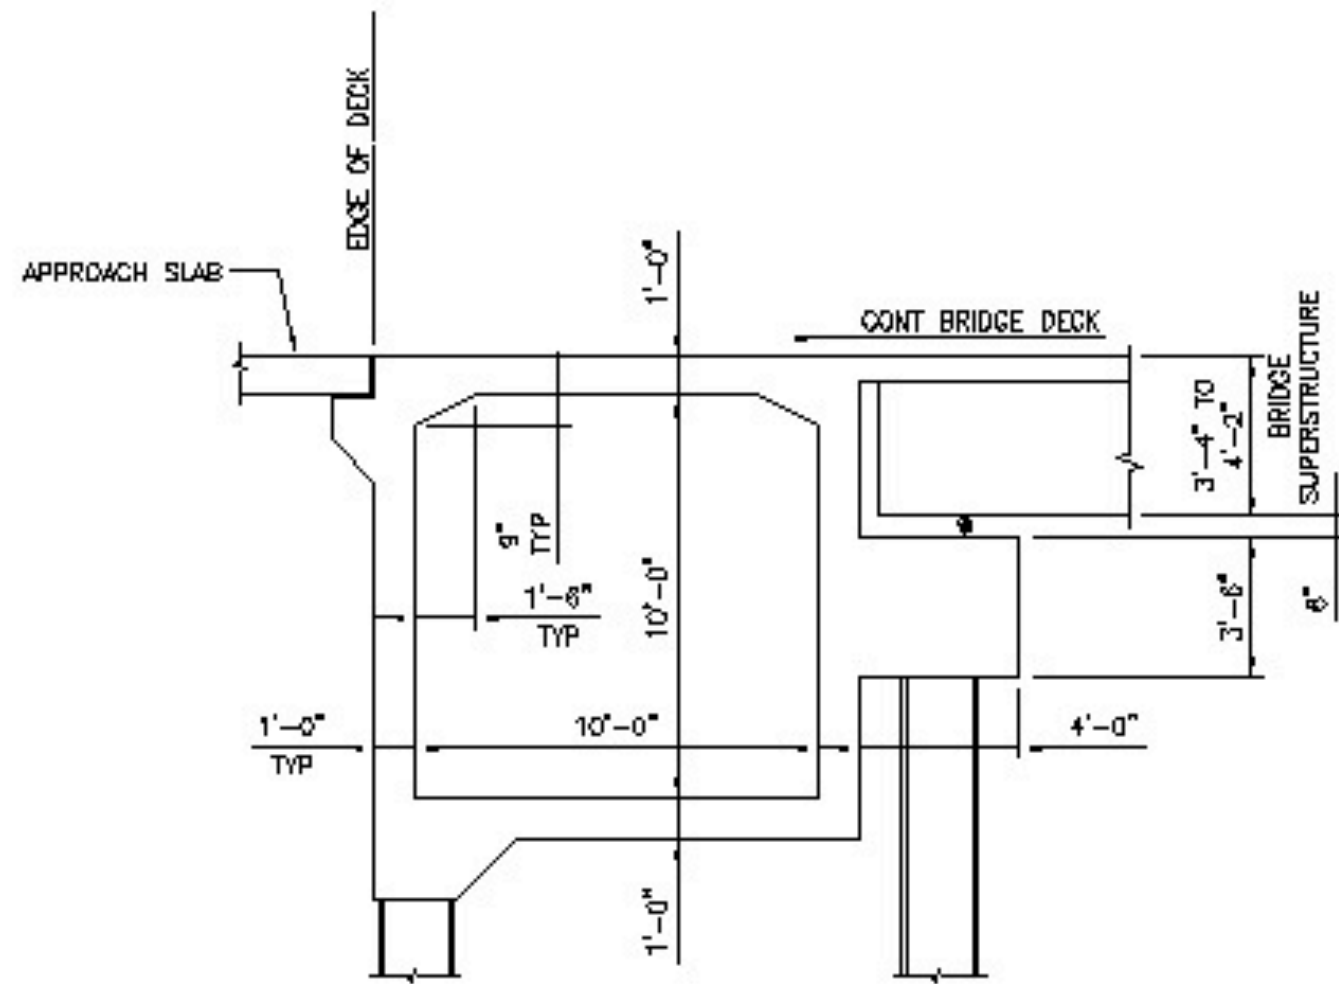
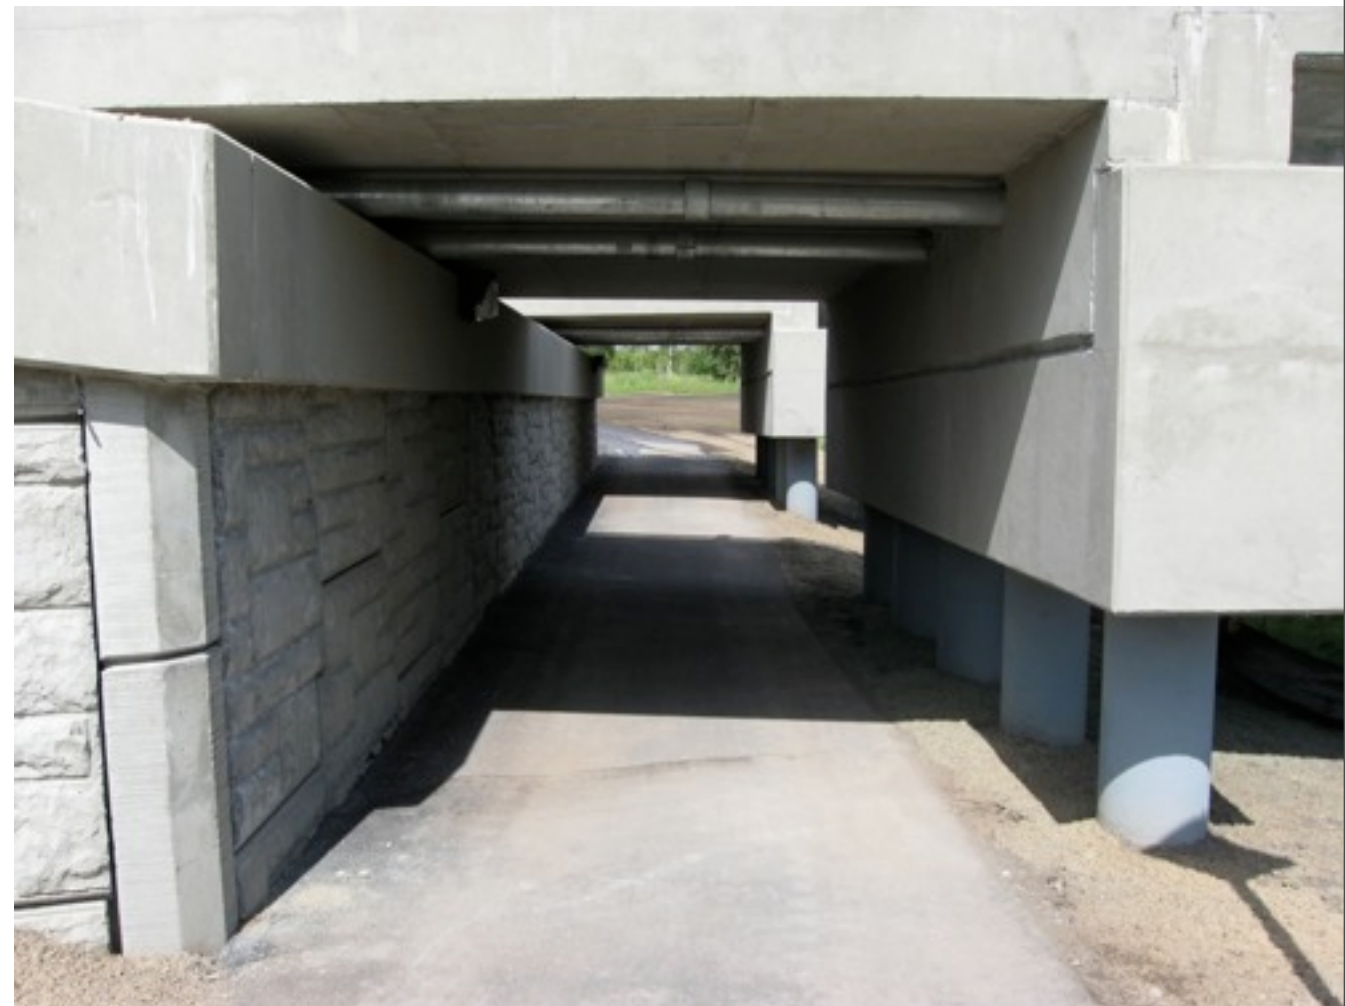
Design Challenges

- Early (prior to 2007) concept
- Final Design

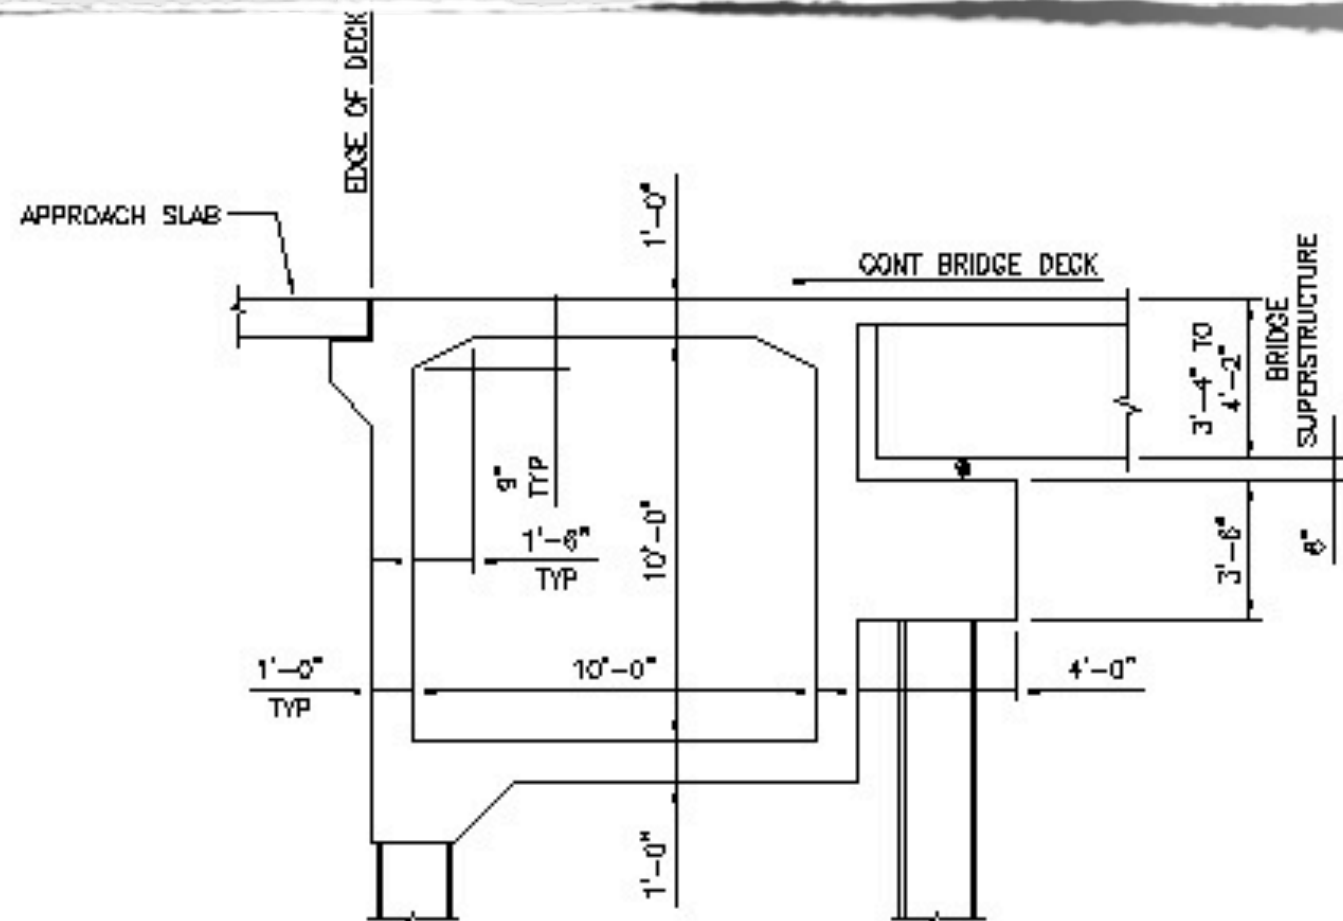
Design Concerns

- Foundation type

“Spread Footings at the Bridge: I spoke with ...our GeoTech department and the recommendation for spread footings were based on the dense gravel at the site. No deep borings were done because of this finding. If [deep foundations] are used.... deep borings will be required. I do not believe our time line allows for this.”

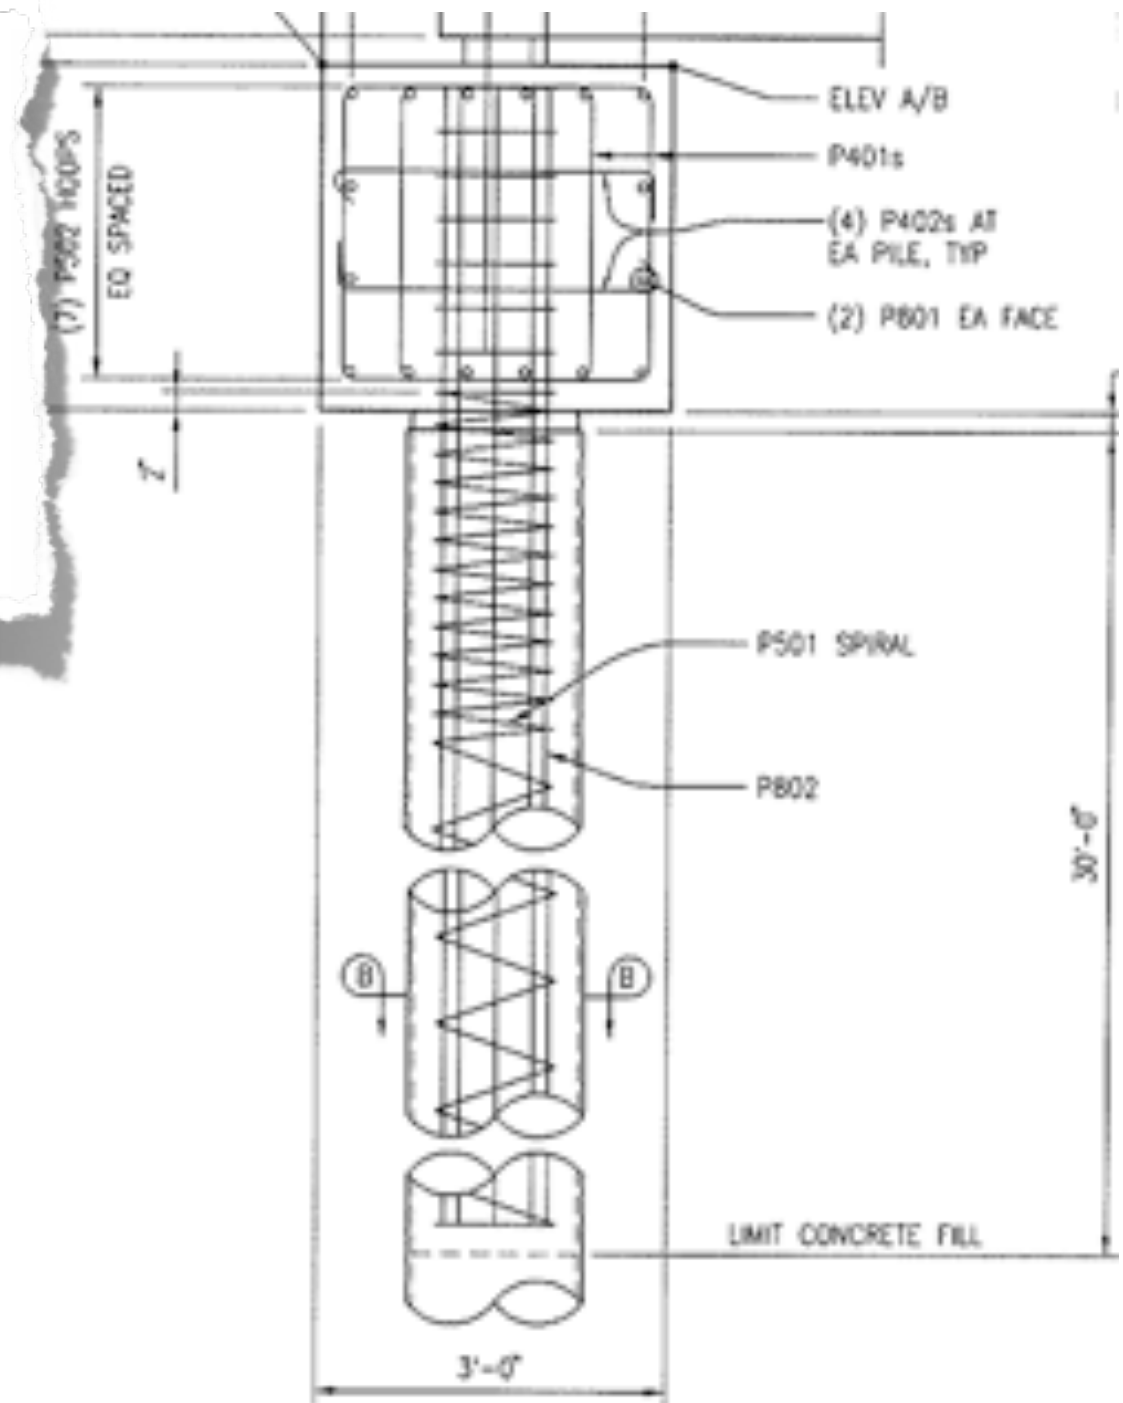
Design Concerns

3.10.9.4.3a General

Where inelastic hinging is invoked as a basis for seismic design, the force effects resulting from plastic hinging at the top and/or bottom of the column shall be calculated after the preliminary design of the columns has been completed utilizing the modified design forces specified in Article 3.10.9.4.2 as the seismic loads. The consequential forces resulting from plastic hinging shall

- Frozen ground case increases shear demand per AASHTO LRFD Article 3.10.9.4.3.a
- As per the Alaska DOT “Seismic Pier Design for Steel Pipe Pile Extensions with Concrete Cap Beam”

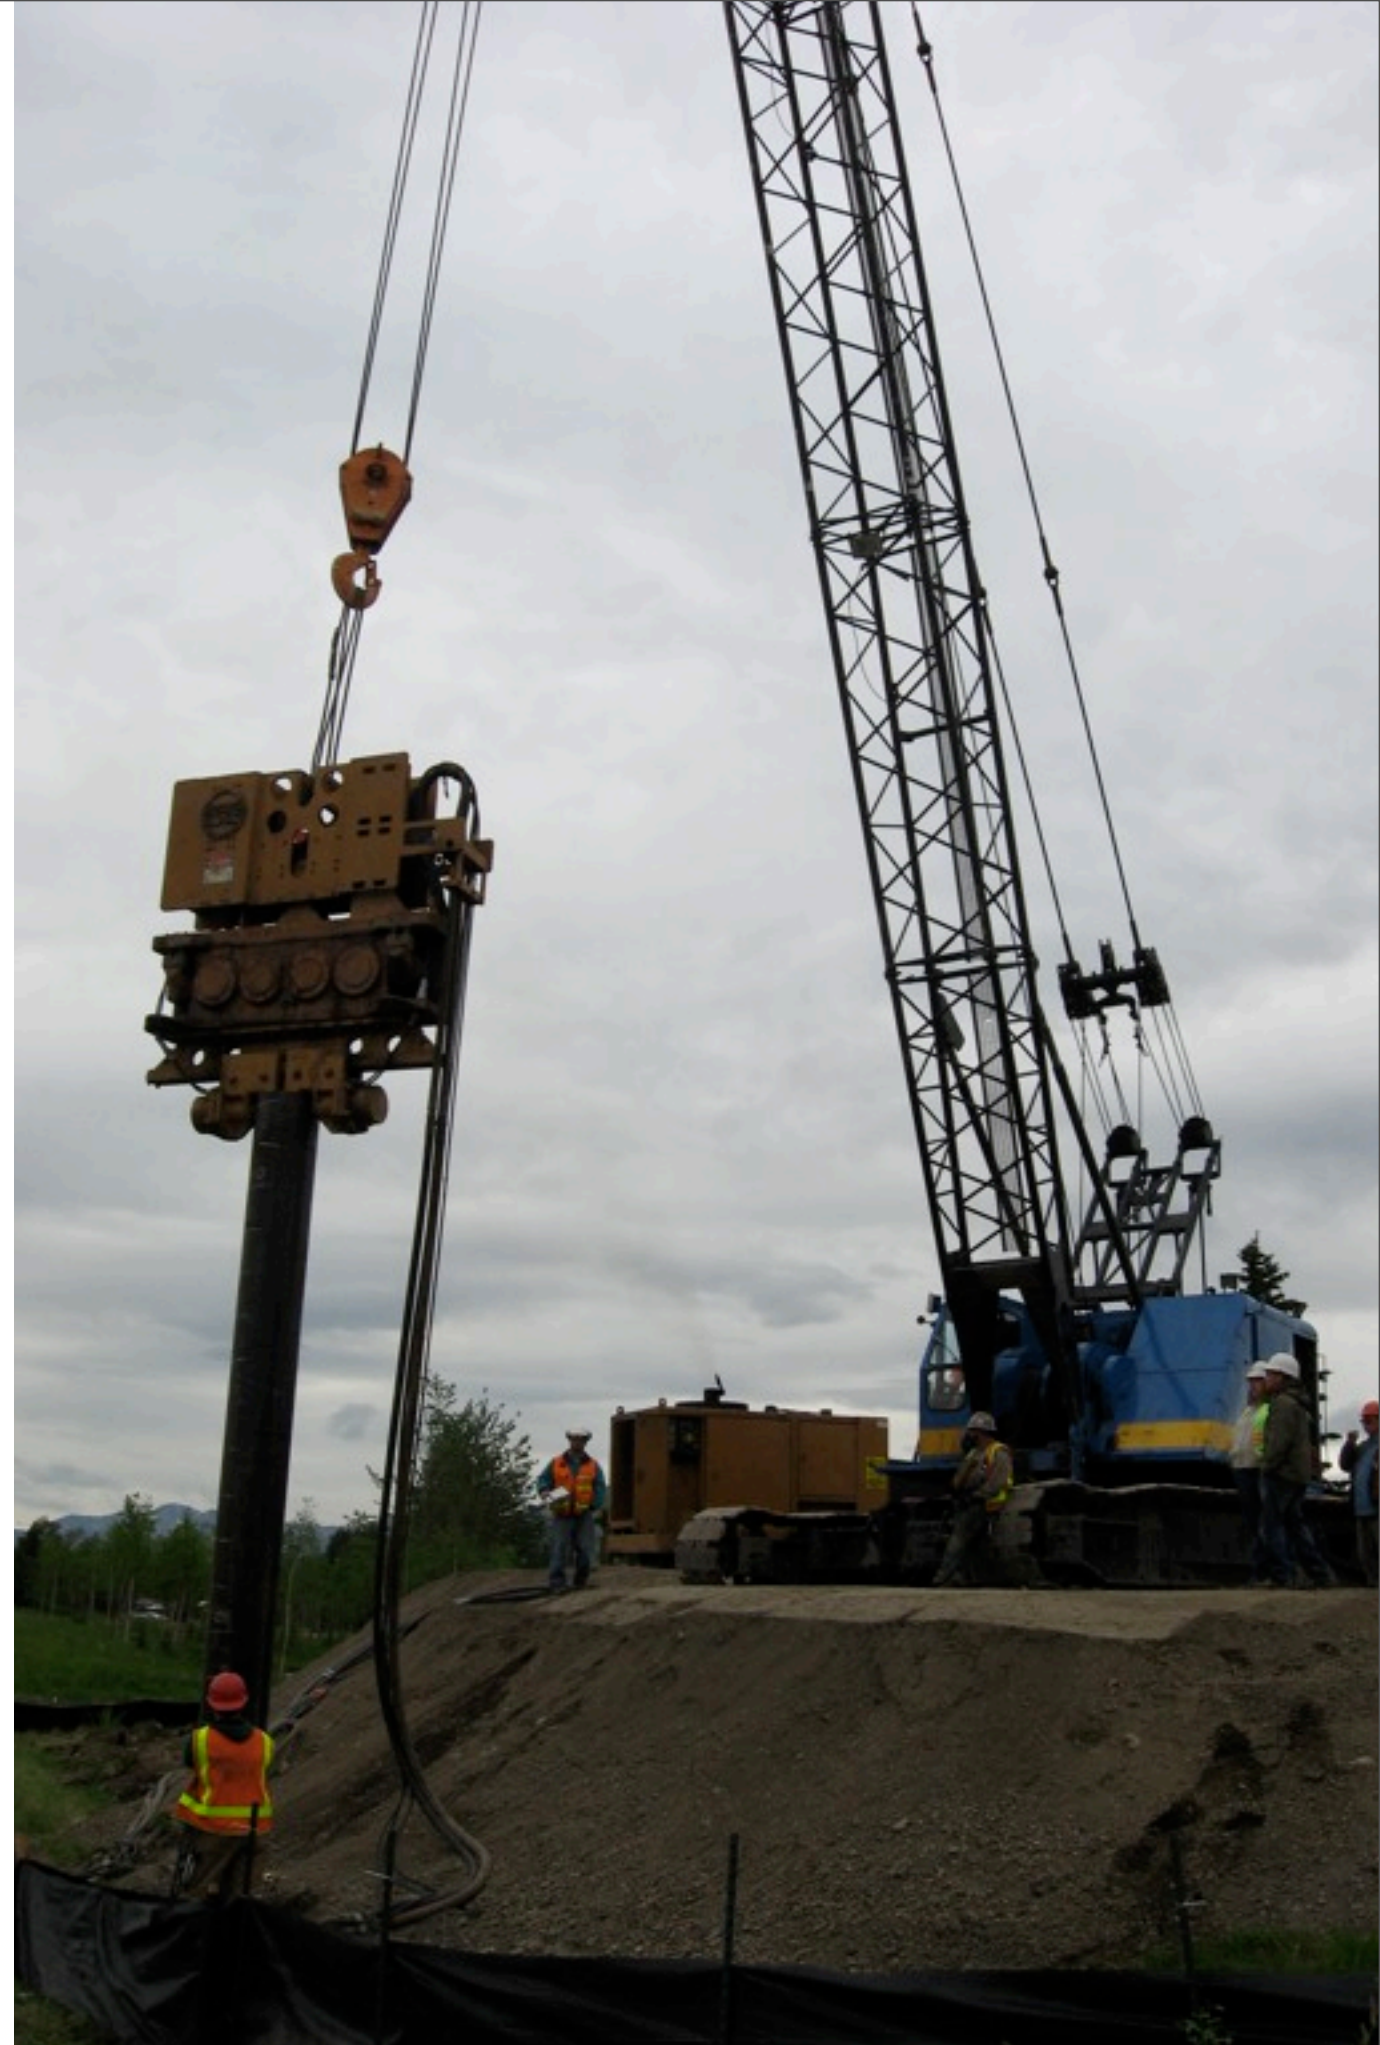
Driving Piles

- Boulder encountered while driving affecting two piles
- 24" diameter casing was installed to the boulder
- Boulder was drilled to allow 18" diameter pile installation
- Annulus between the 18" pile and the casing was filled with a Bentonite Slurry.

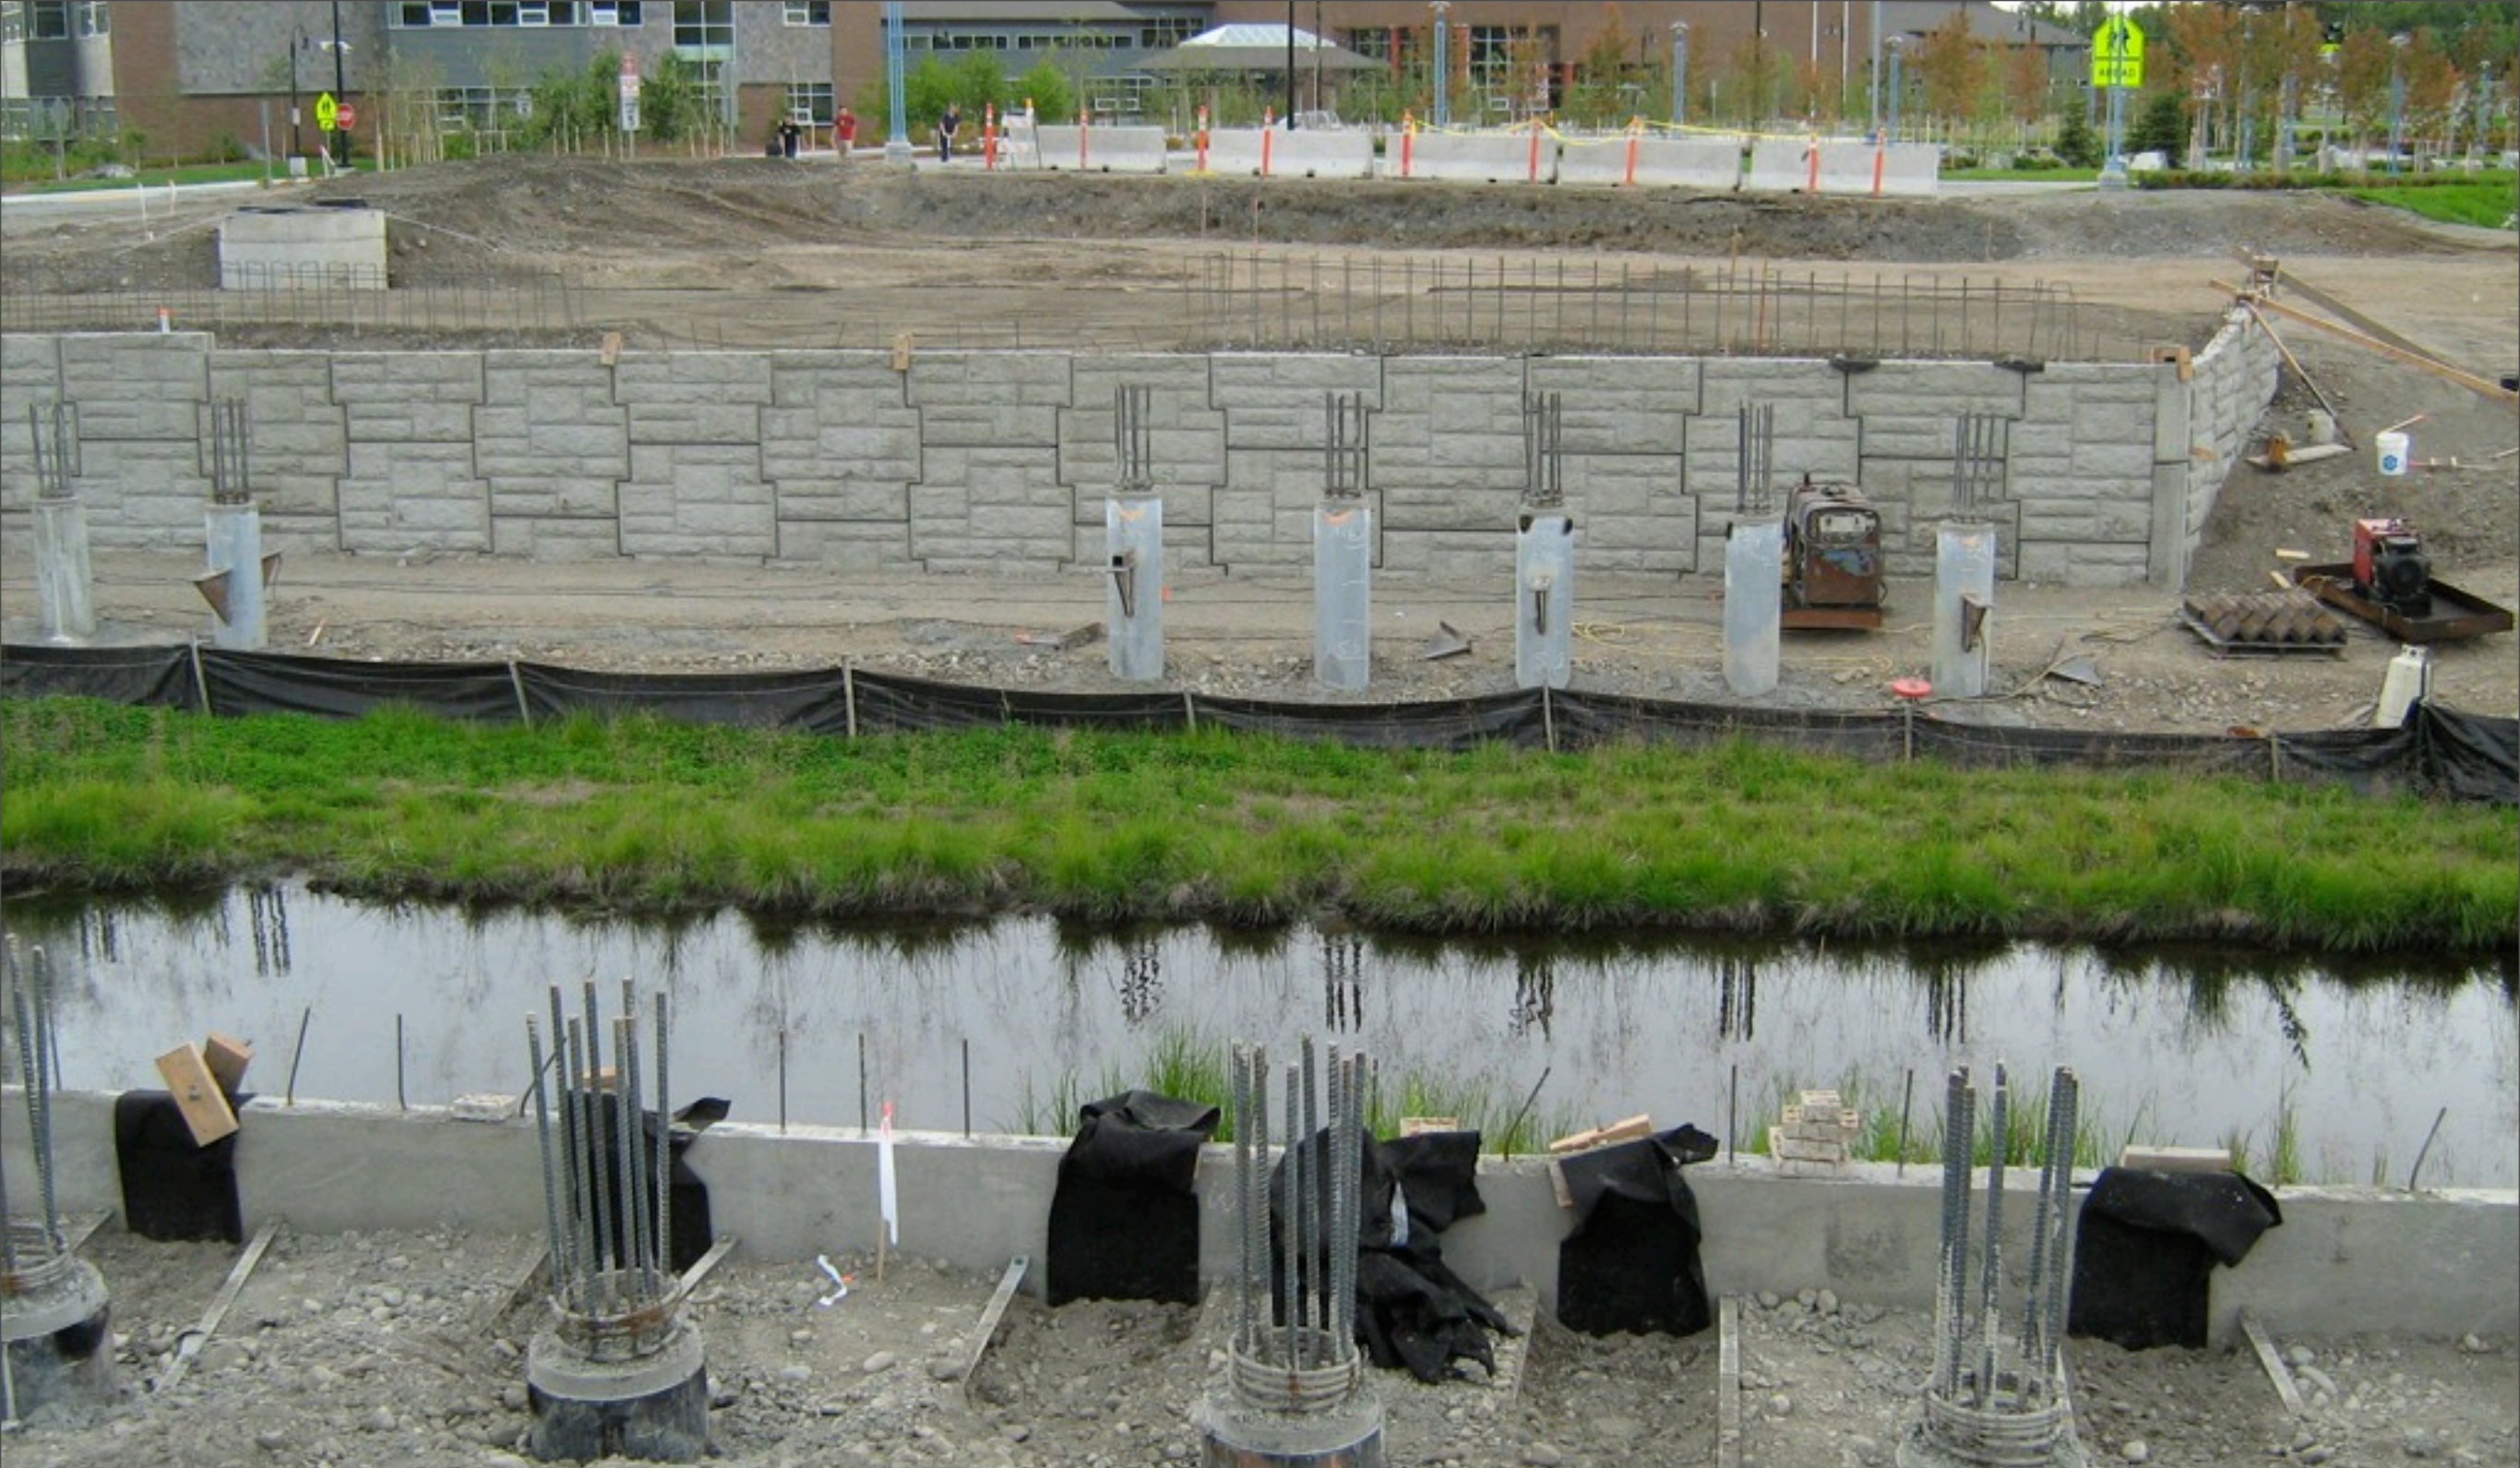
Piles Driven, Concrete
cores cast, MSE Wall

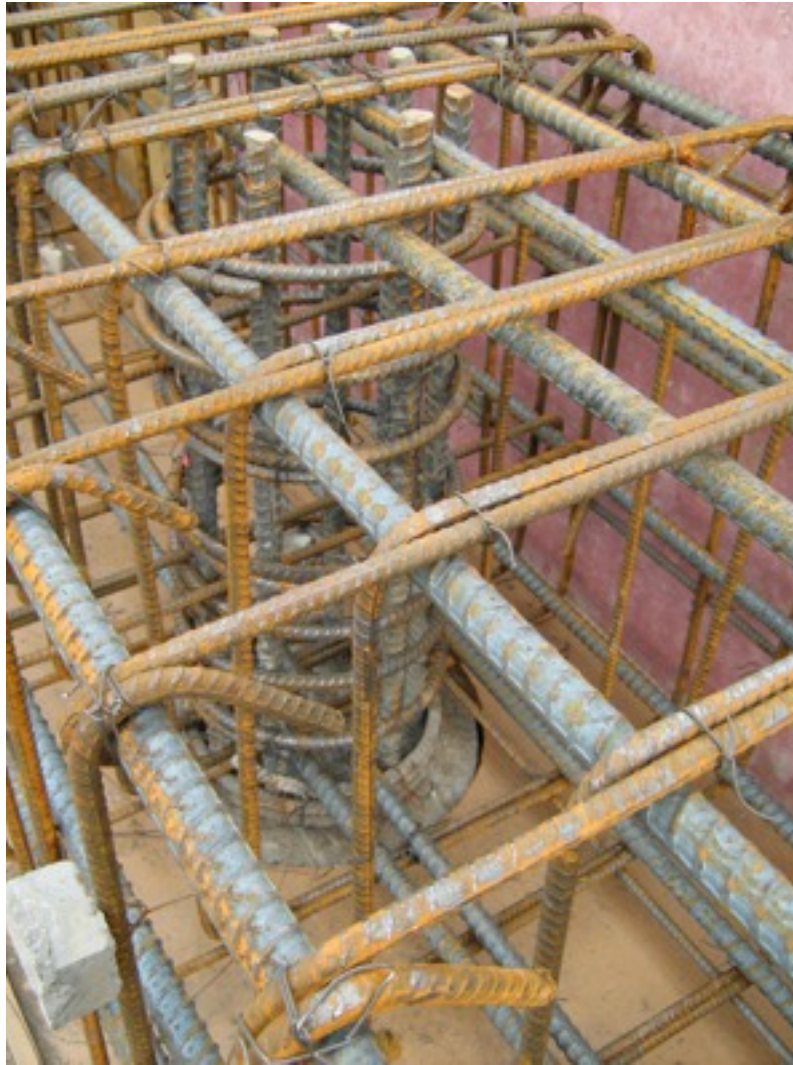
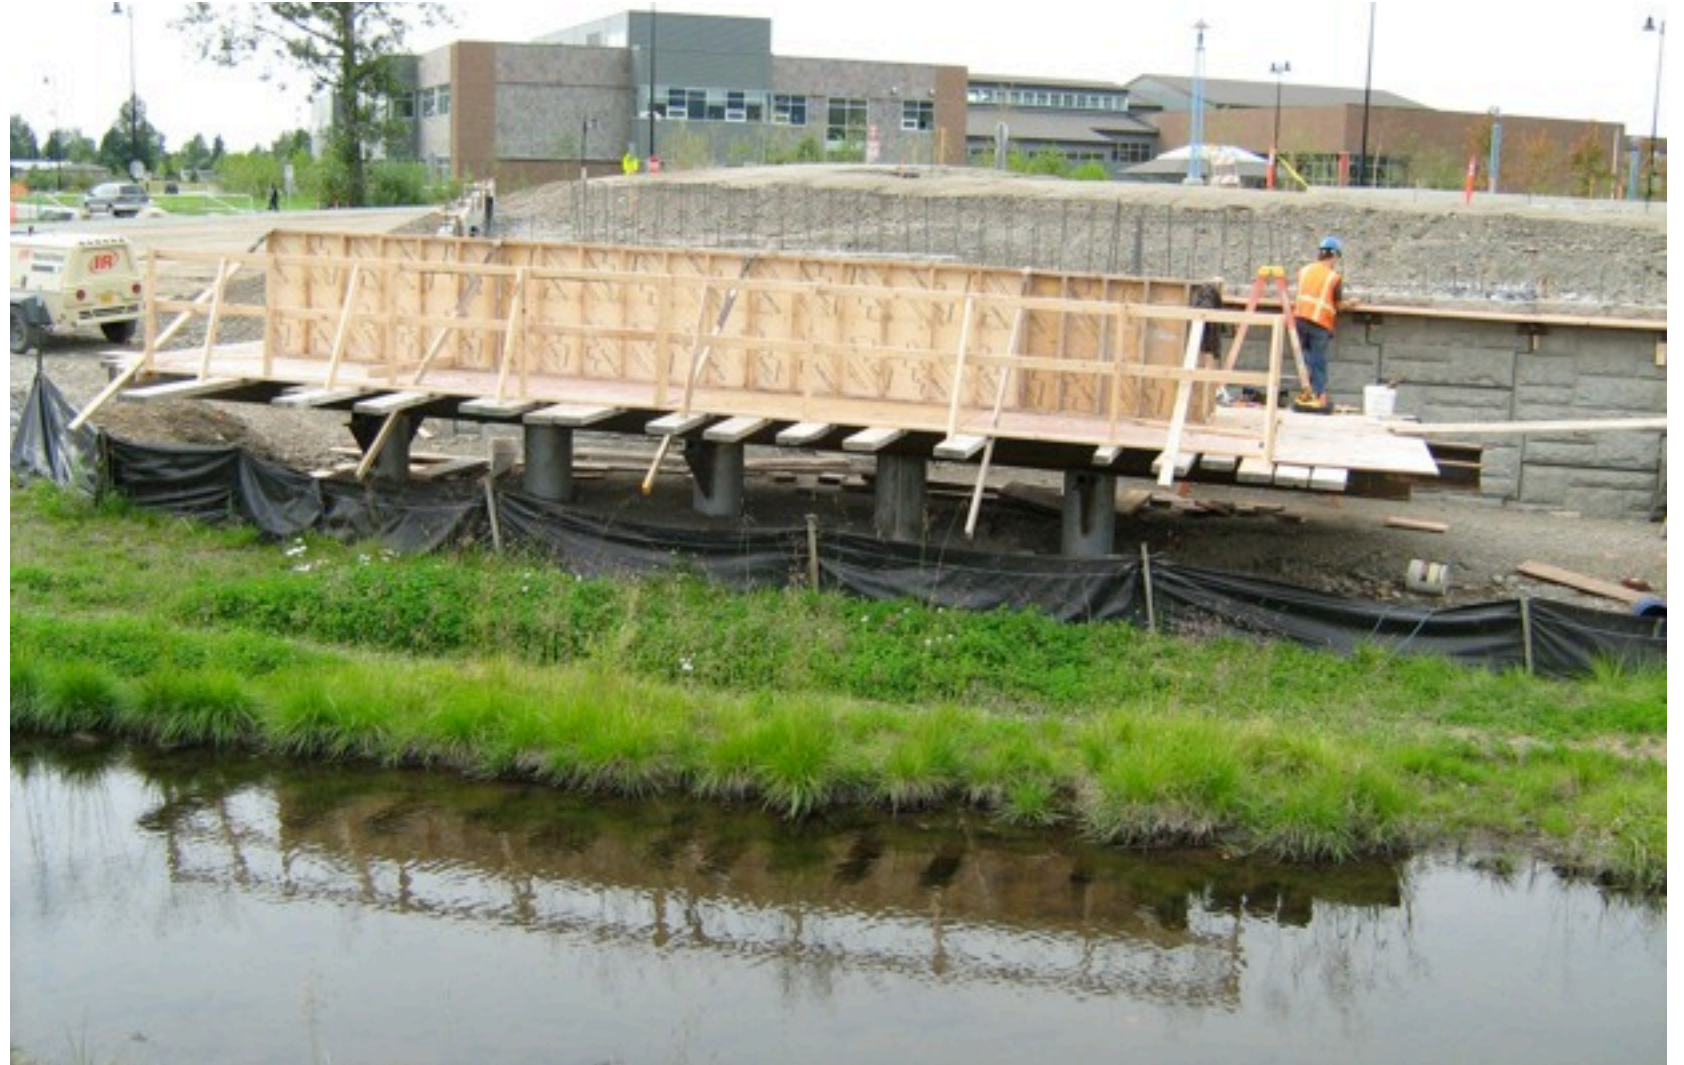
Forming up Piers and Abutment - August 18, 2008

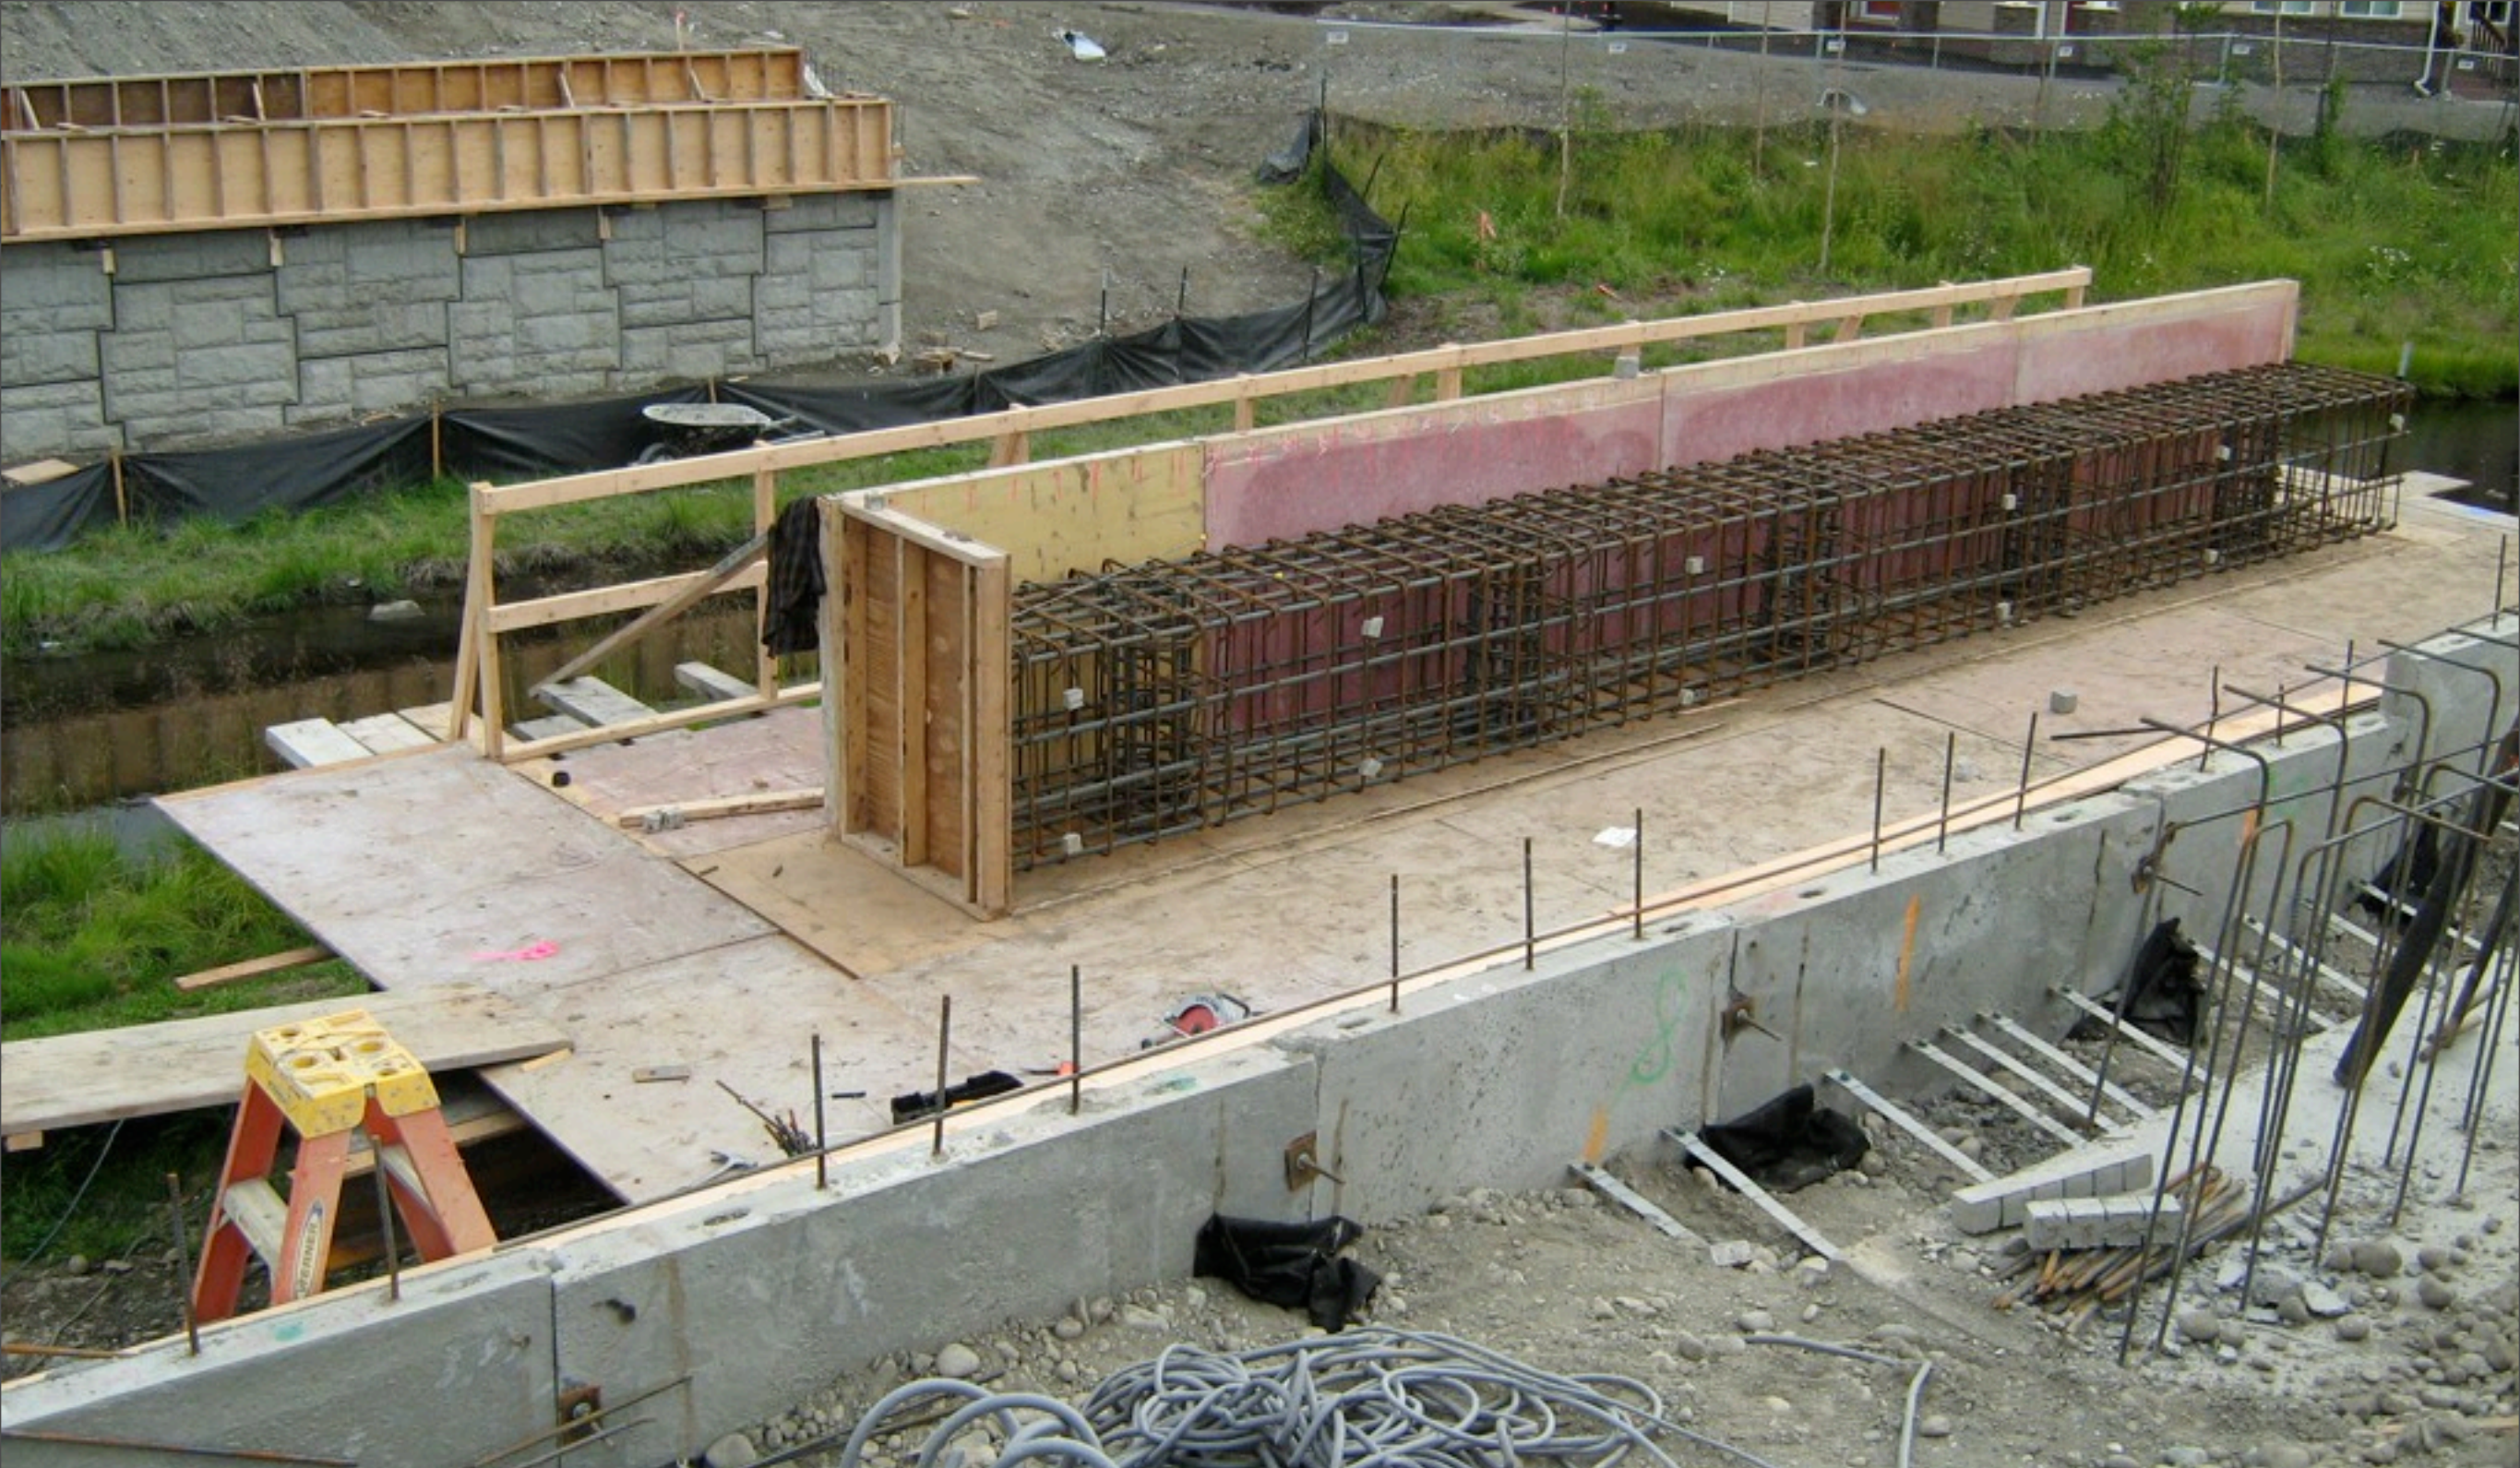
Pier 2 Formwork

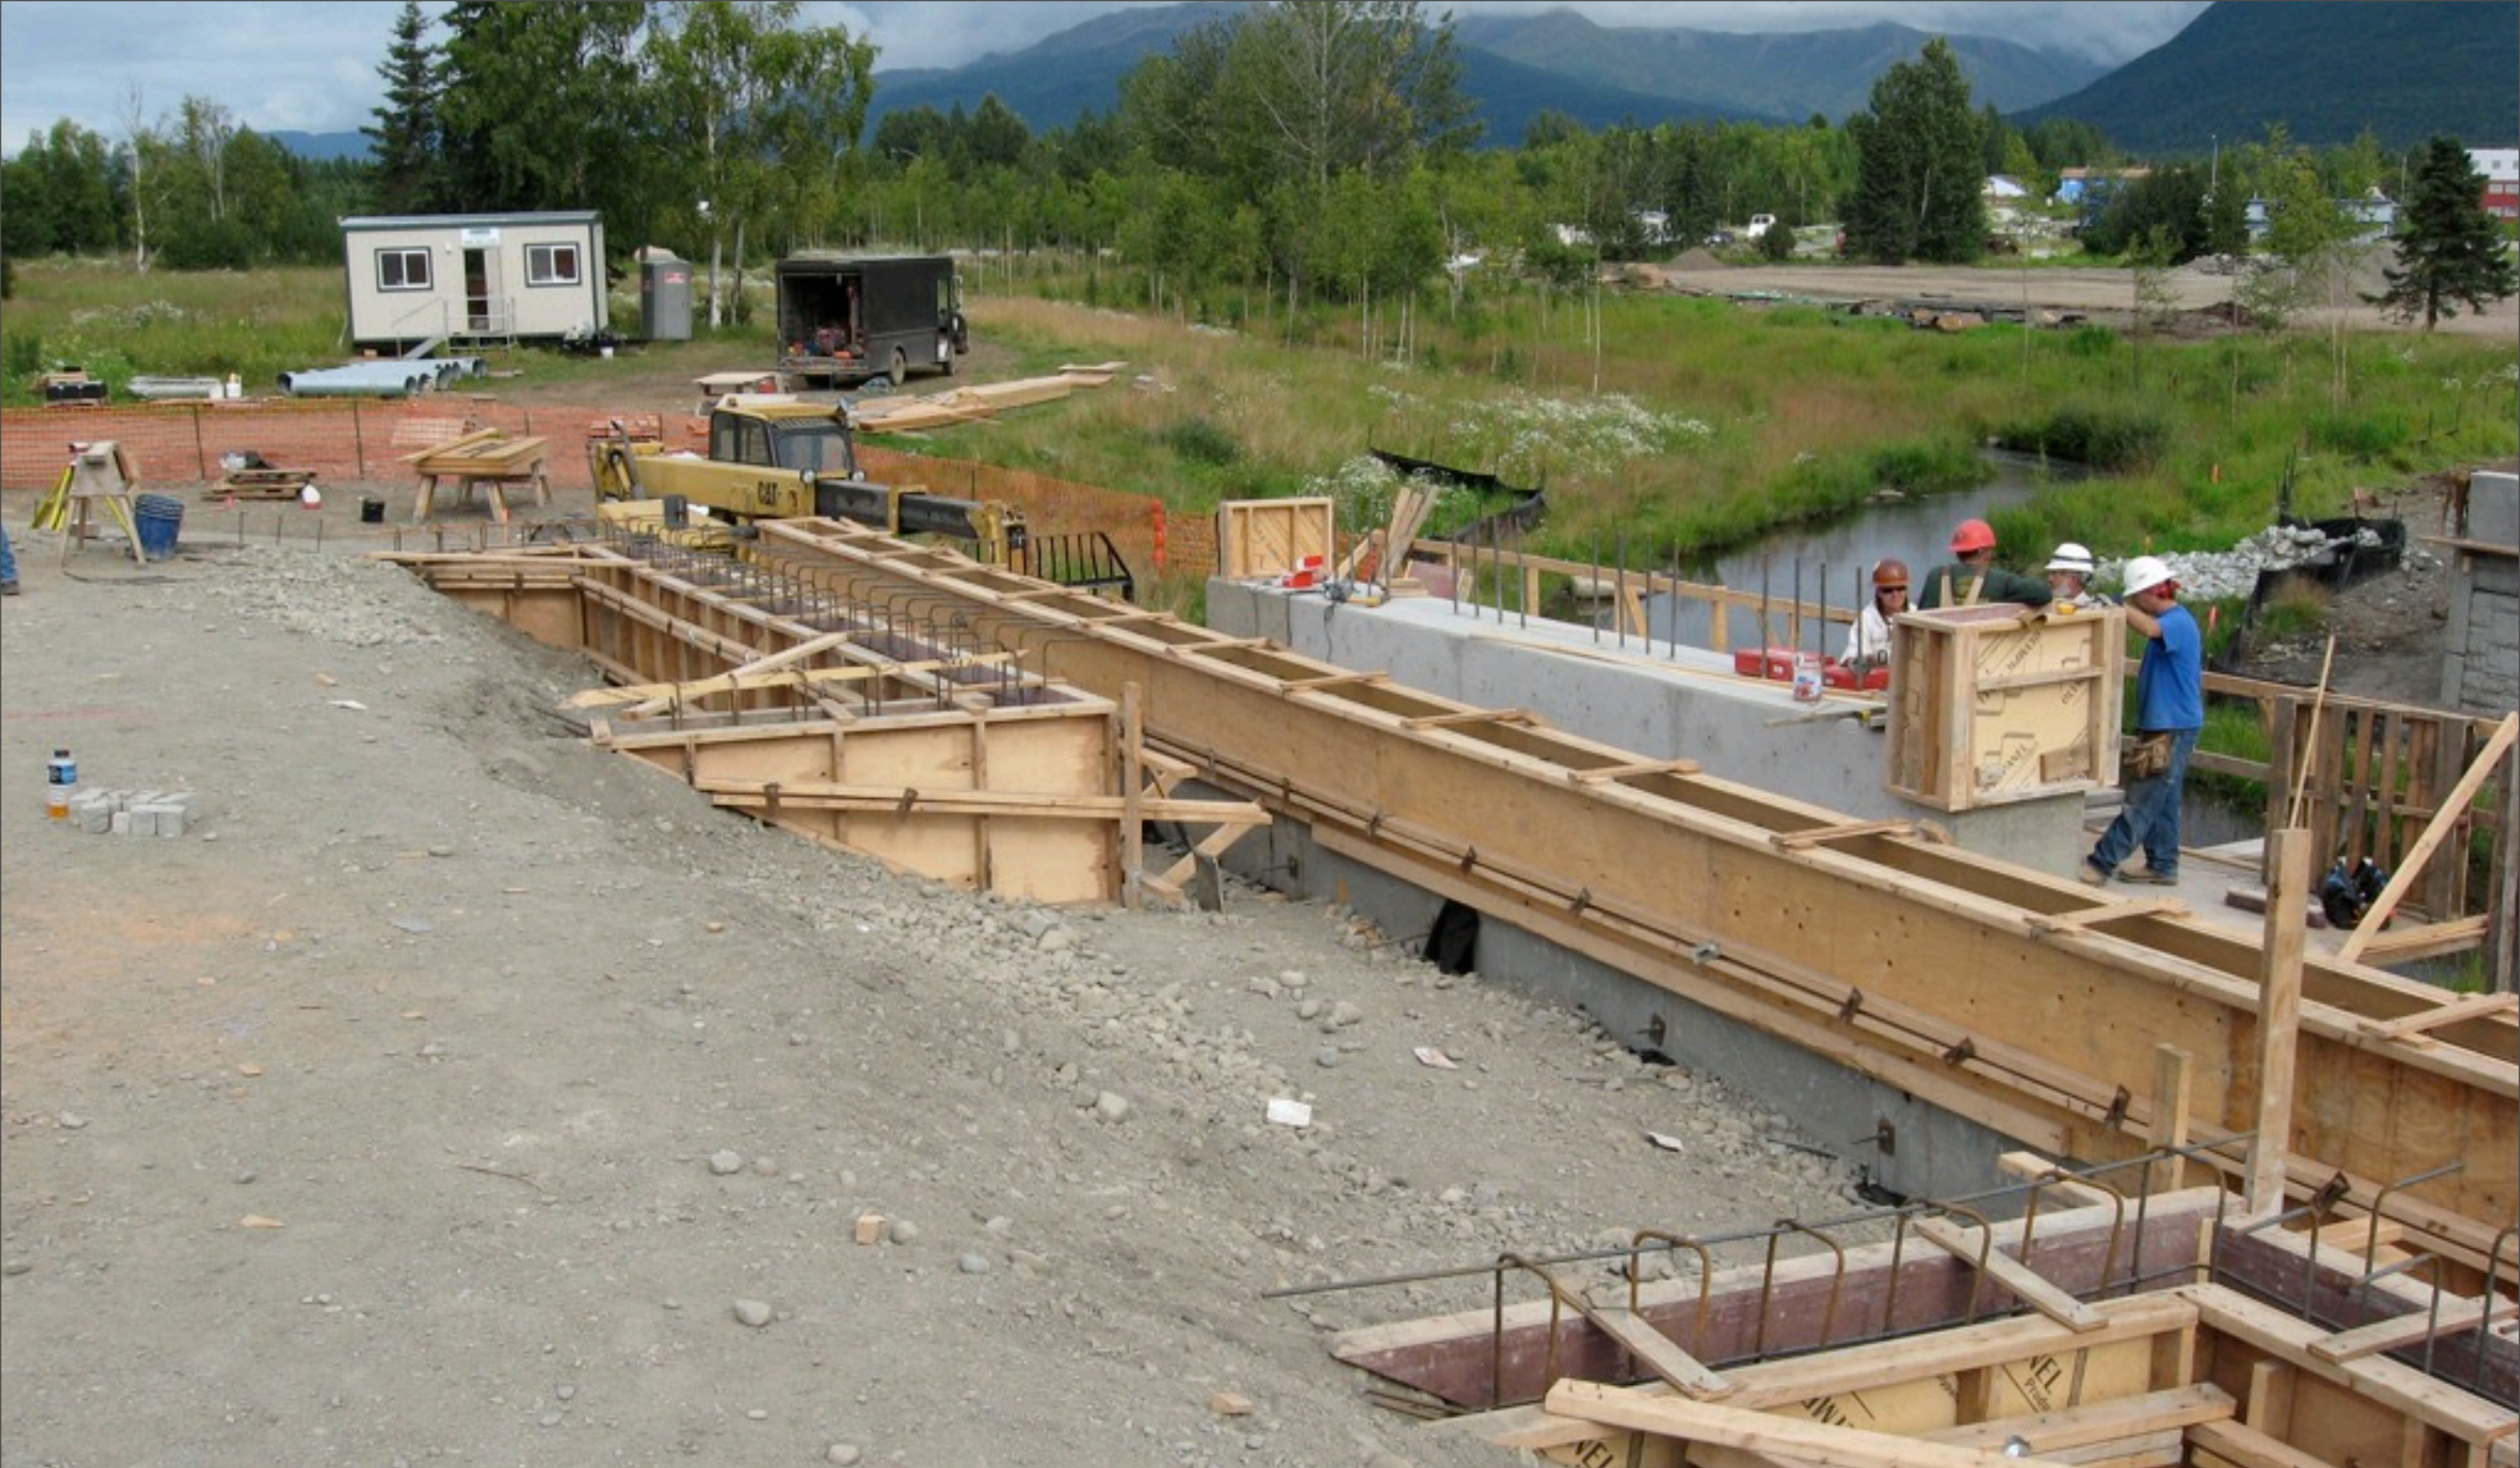
Forming Abutment 1, MSE Coping
